REPORT 65507/S/1

PORT ARTHUR HOUSE, NAFC SHETLAND

FLOOR LOAD TESTS

23 September 2019

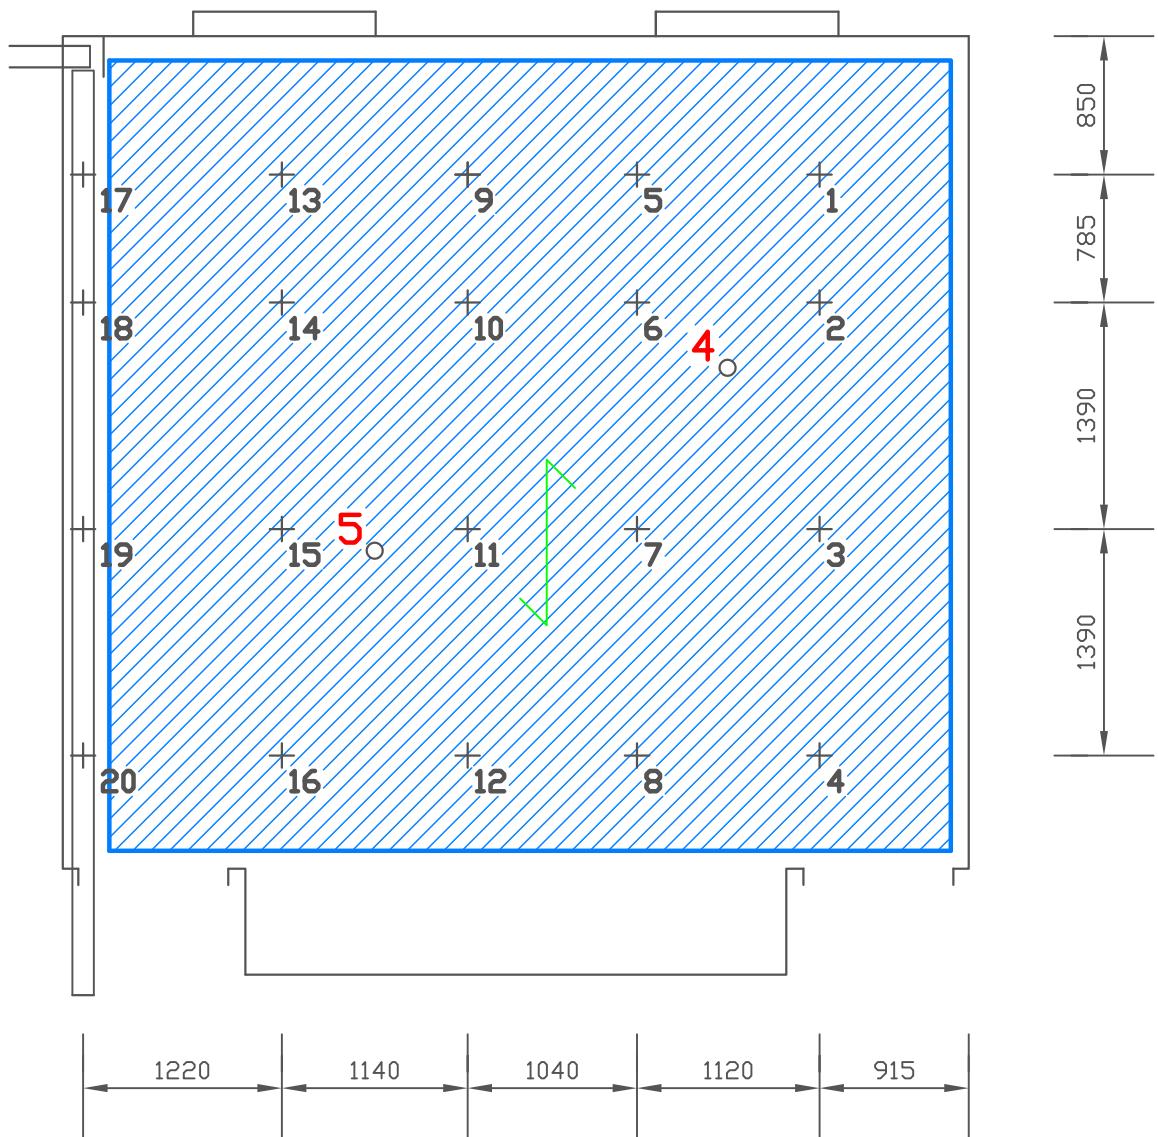
Figure 2 First floor Rooms 19/20 showing layout of tank, positions of gauges and locations of core samples.

Figure 2 shows the positions of the tanks and gauges in Rooms 19/20 along with the gauge numbering. Core sample locations and numbers are also shown. The deflections and recoveries at mid-span positions in each of the three loadings were:

Gauge	First loading cycle		Second loading cycle		Third loading cycle (24 hour)	
	Peak deflection mm	Recovery %	Peak deflection mm	Recovery %	Peak deflection mm	Recovery %
3	1.78	56	1.07	92	1.14	90
7	3.84	52	2.09	91	2.22	89
11	4.82	50	2.56	90	2.71	90
15	4.45	54	2.52	91	2.64	91
19	2.16	63	1.41	92	1.44	93

Occasional creaking noises were heard during the first loading cycle.

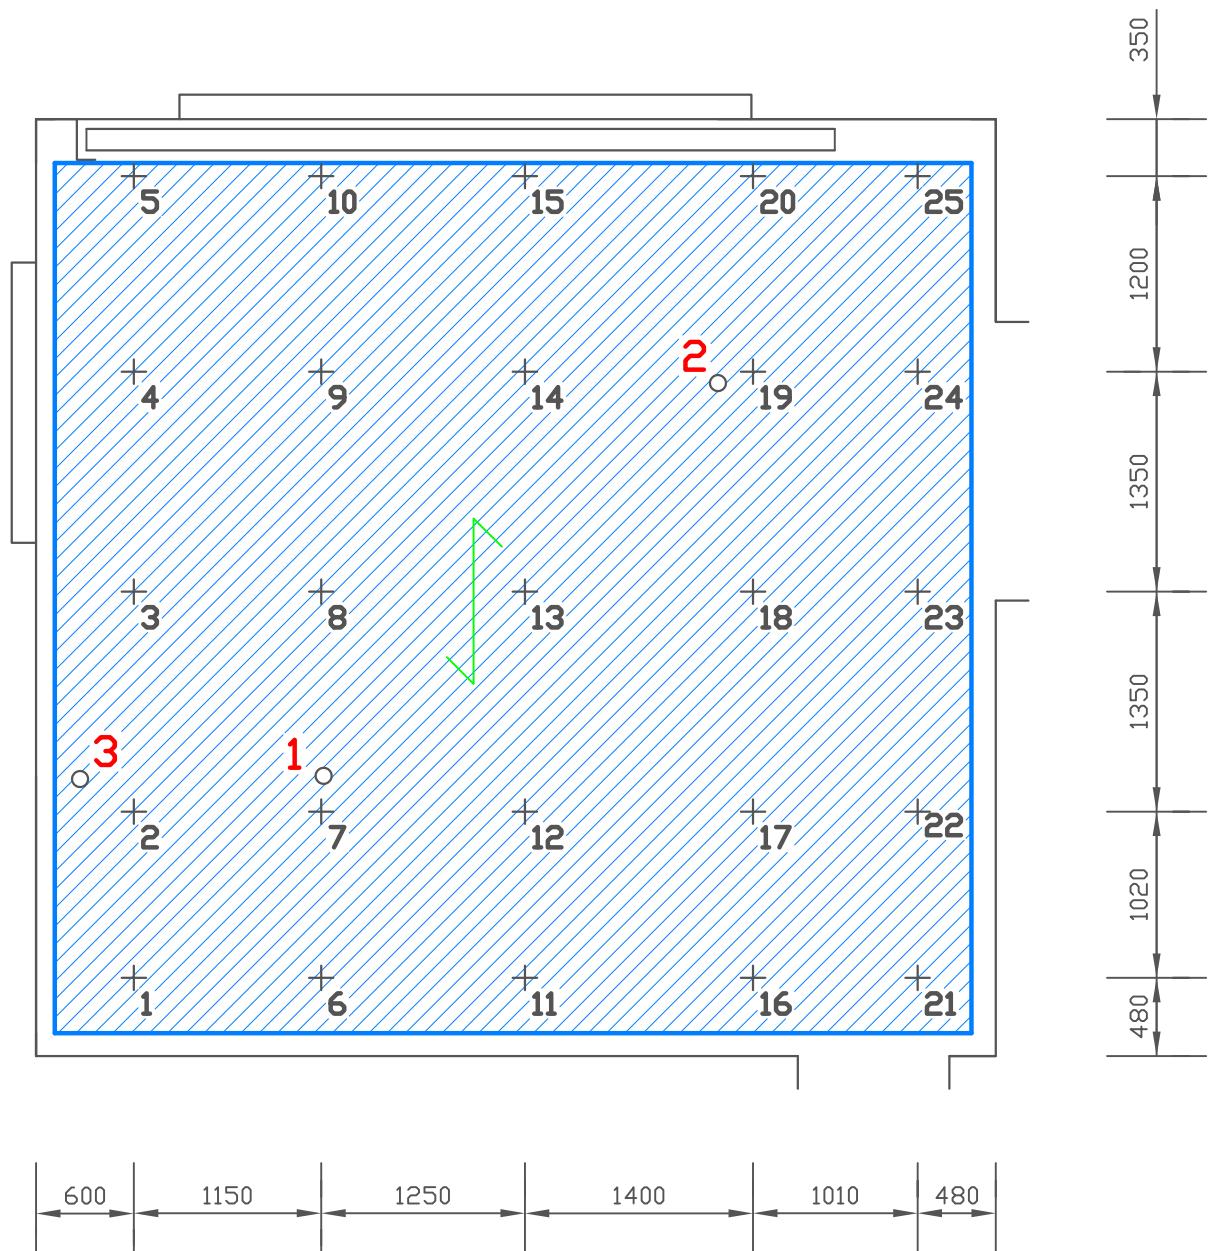
Figure 3 First floor lounge showing layout of tank, positions of gauges and locations of core samples.

Figure 3 shows the positions of the tanks and gauges in the Lounge along with the gauge numbering. Core sample locations and numbers are also shown. The deflections and recoveries at mid-span positions in each of the three loadings were:

Gauge	First loading cycle		Second loading cycle		Third loading cycle (24 hour)	
	Peak deflection mm	Recovery %	Peak deflection mm	Recovery %	Peak deflection mm	Recovery %
3	2.84	47	1.61	85	1.41	>100
8	6.32	54	3.88	90	3.62	98
13	7.65	55	4.74	90	4.42	99
18	5.24	61	3.55	91	3.34	99
23	1.90	72	1.48	93	1.41	100

Many creaking noises were heard during the first loading cycle.

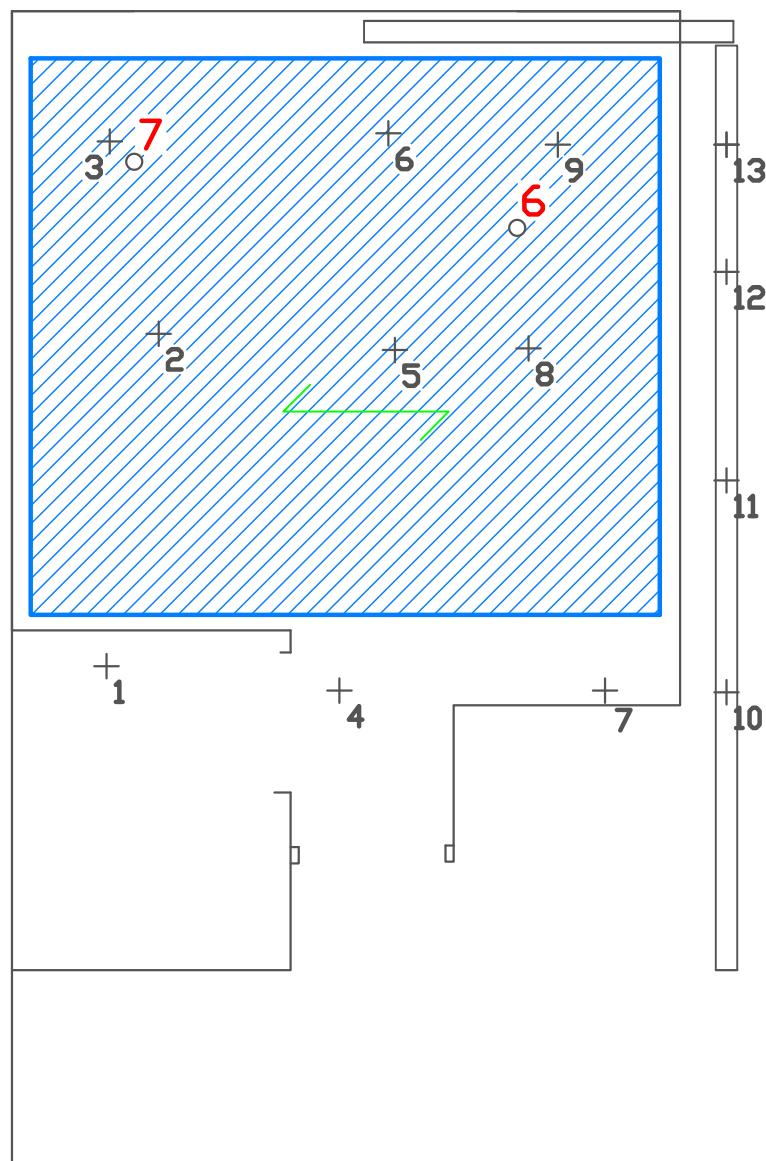
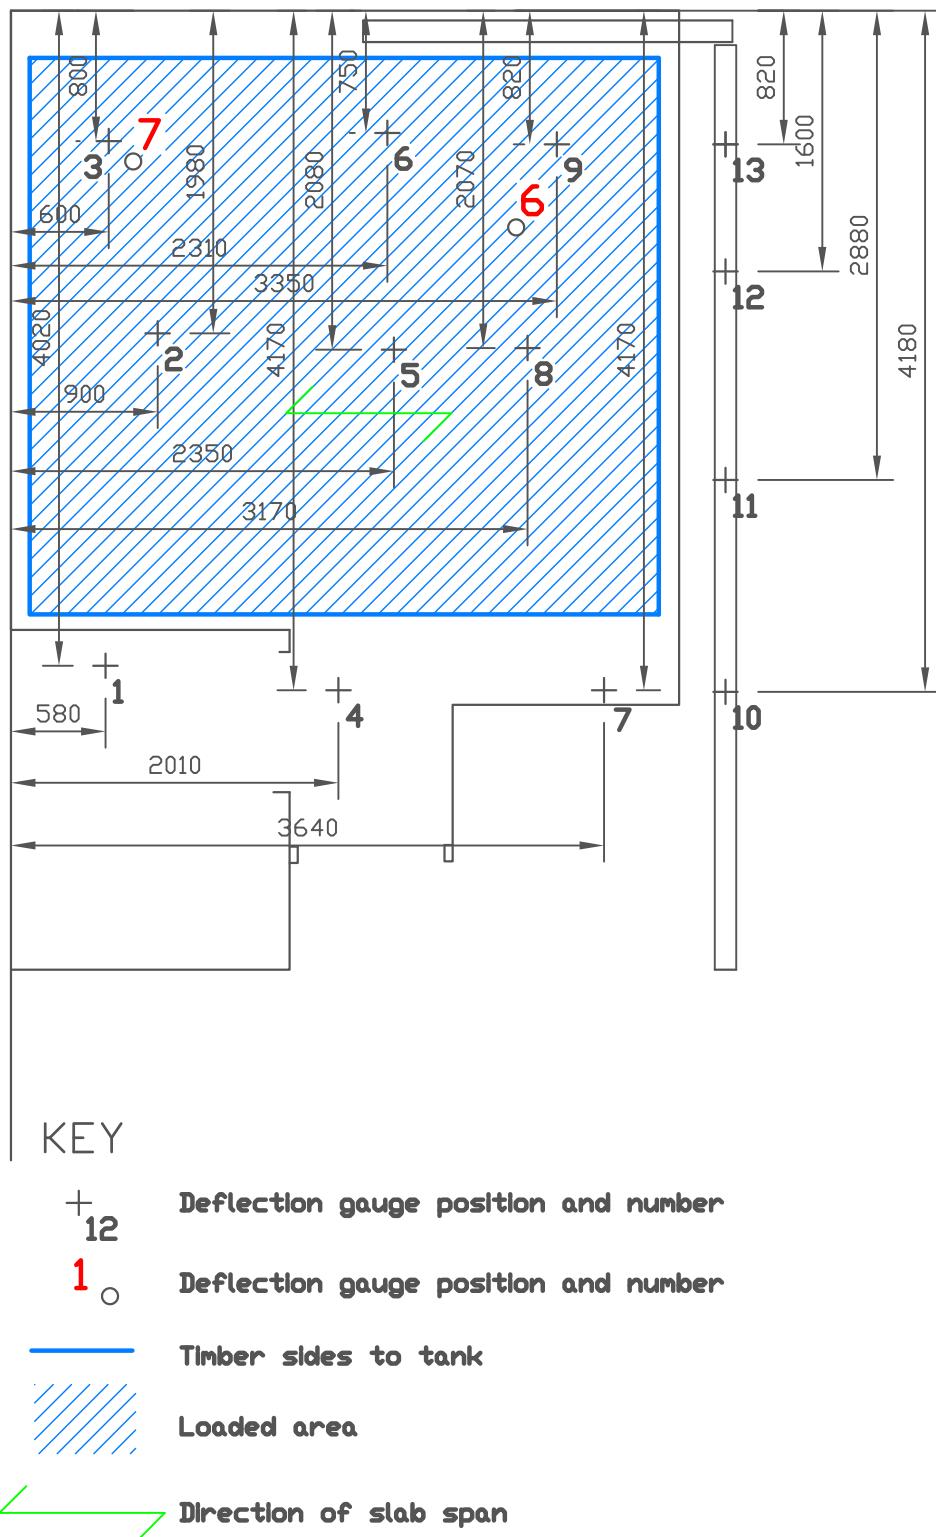
Figure 4a First floor Room 18 showing layout of tank, positions of gauges and locations of core samples.

Figures 4a and 4b show the positions of the tanks and gauges in Rooms 18 along with the gauge numbering. Core sample locations and numbers are also shown. In this area intense services below the slab restricted the positions at which gauges could be installed. The deflections and recoveries at span positions in each of the three loadings were:

Gauge	First loading cycle		Second loading cycle		Third loading cycle (24 hour)	
	Peak deflection mm	Recovery %	Peak deflection mm	Recovery %	Peak deflection mm	Recovery %
5	3.35	85	2.94	>100	3.00	100
6	1.97	75	1.57	>100	1.61	>100
8	3.11	86	2.79	>100	2.86	>100
9	1.50	80	1.26	>100	1.30	>100

No noises were reported during the loading.
