REPORT 65507/S/1

PORT ARTHUR HOUSE, NAFC SHETLAND

FLOOR LOAD TESTS

23 September 2019

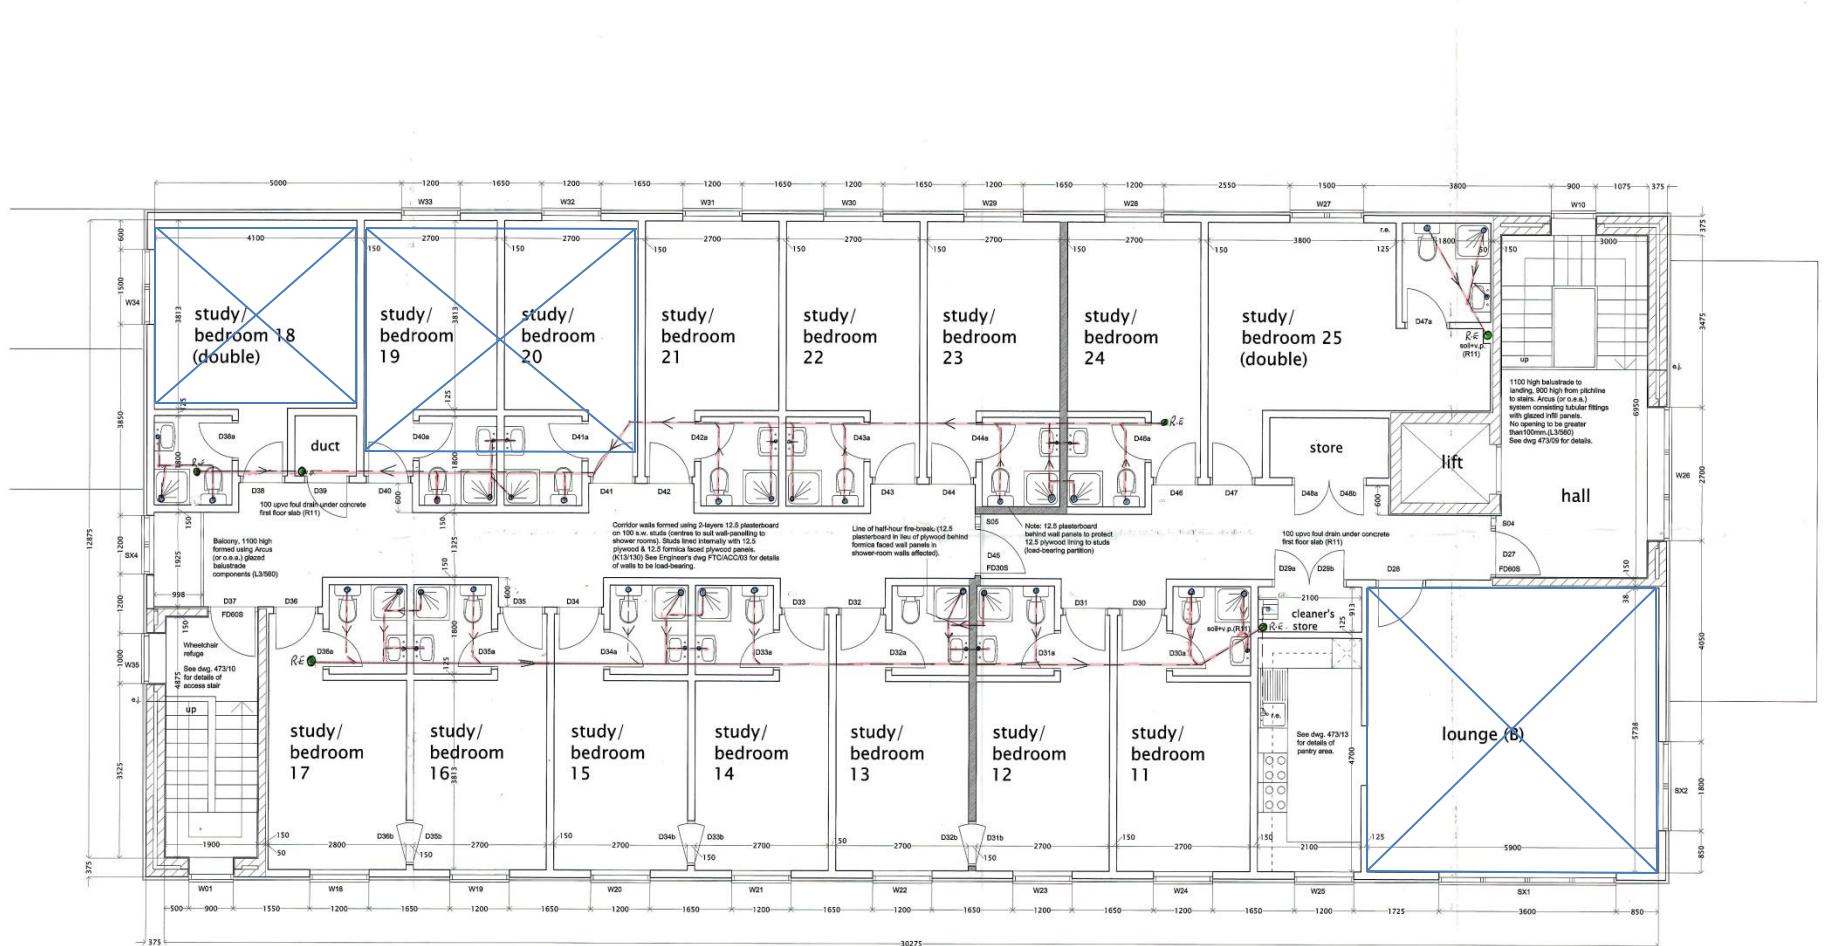
Three tests were undertaken these being in: rooms 19/20 combined, the first floor lounge and room 18 (Figure 1). In advance of Sandberg attending site the partition walls between rooms 19 and 20 had been removed along with floor finishes and other fittings that would have obstructed assembly of the test setup.

The three test locations are indicated on Figure 1.

Figure 1 shows the positions of the three test areas within the building. Figures 2, 3 and 4a and 4b show the positions of tanks and instruments relative to the internal faces of walls on the first floor. When assessing the exercise it should be noted that the load bearing perimeter walls to the ground floor are thicker than those on the first floor.

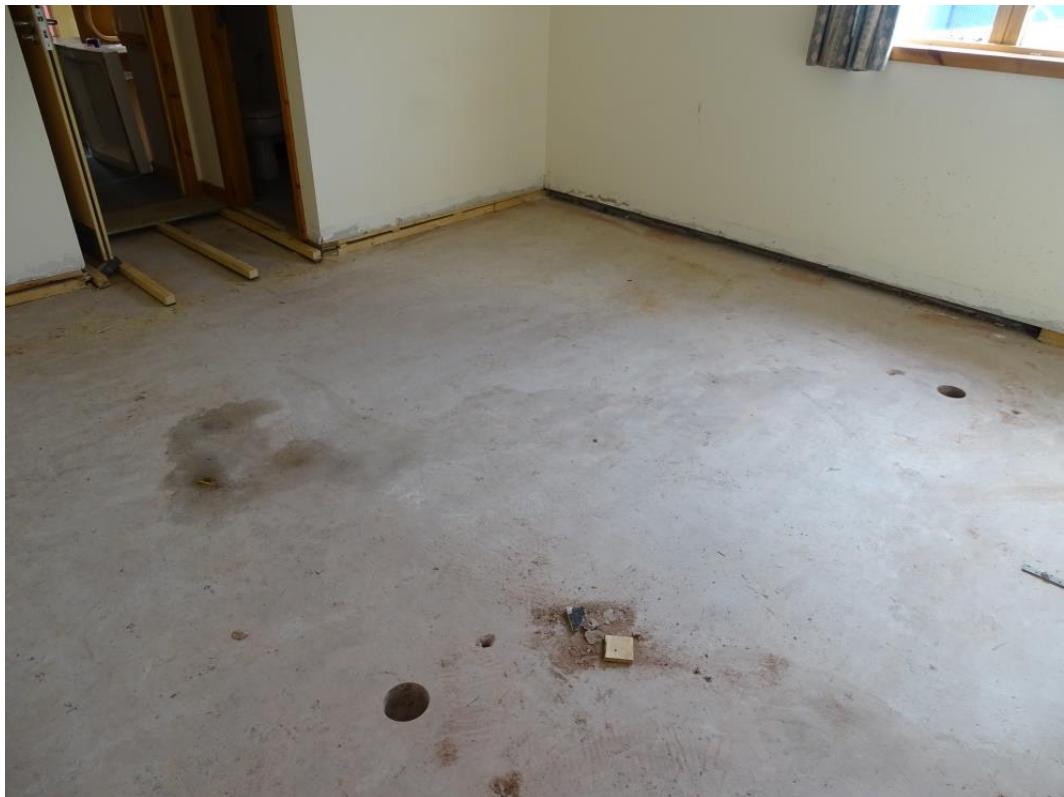
Photograph 10 Room 18 empty (showing the two core holes that were cut after the load test)
